Historic, archived document

REGION
6

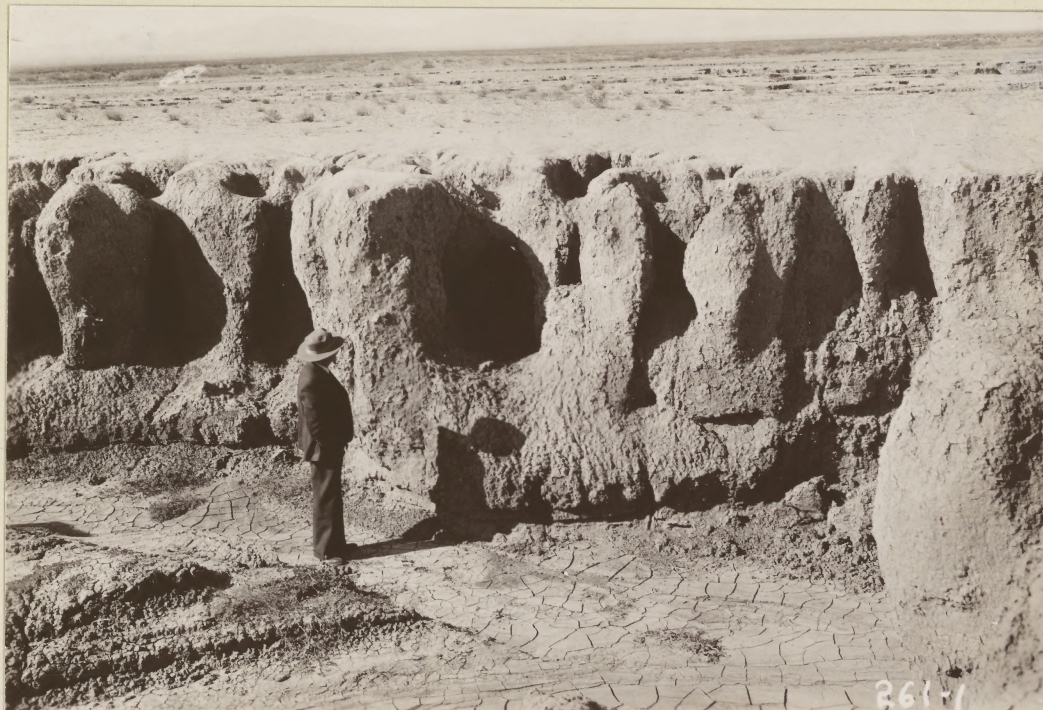
261-1. Arizona.
Gila Project.

San Simon River bottoms. Detail of barranca wall showing method of
side wall cutting and infiltration. February 2, 1935.

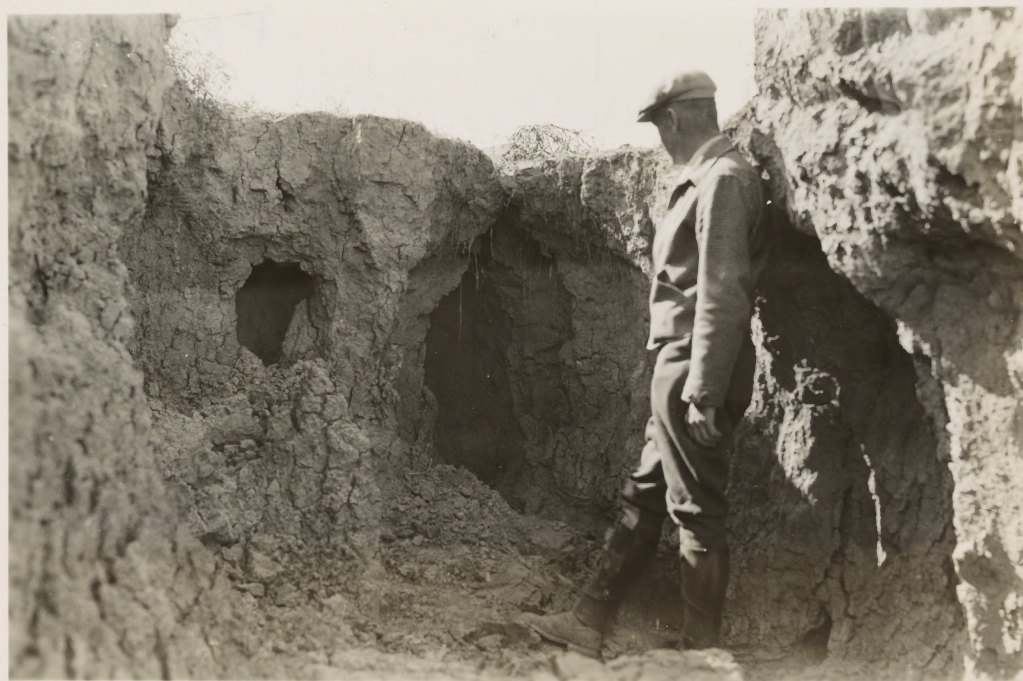
261-2 - Gila Project, Arizona.
EORSION - Gully.

Barracana head showing method of advance by undercutting.
San Simon river bottom - $1\frac{1}{2}$ mi E of Tanque. Feb. 2, 1935.

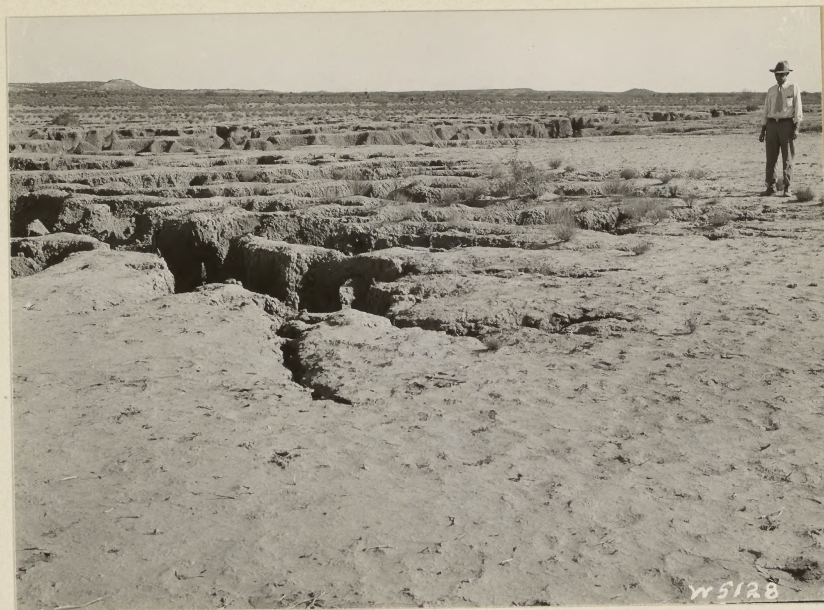
W-5128

W-5128. November 12, 1933. San Simon Valley, Arizona. A detail showing how tributaries work back; drainage of soil helps to kill off vegetation under overgrazing; bared ground accelerates run-off to quicken the destructive processes.

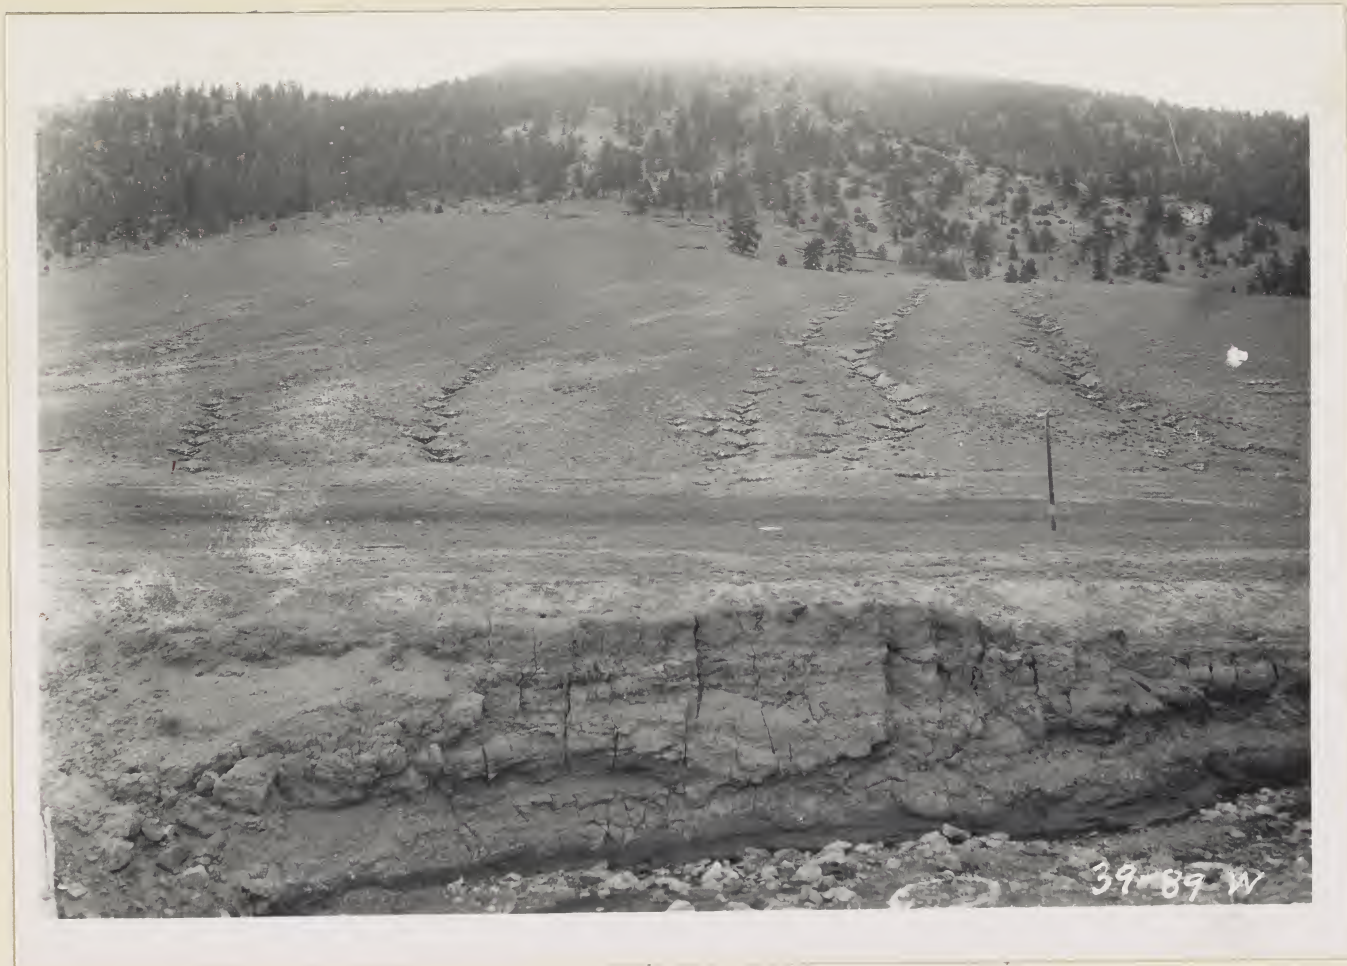
39-89-W
Colorado

The best place to attack the problem of erosion and run-off is at the source. This view shows rows of check dams built on high mountain slopes in Park Range near Trout Creek Pass.

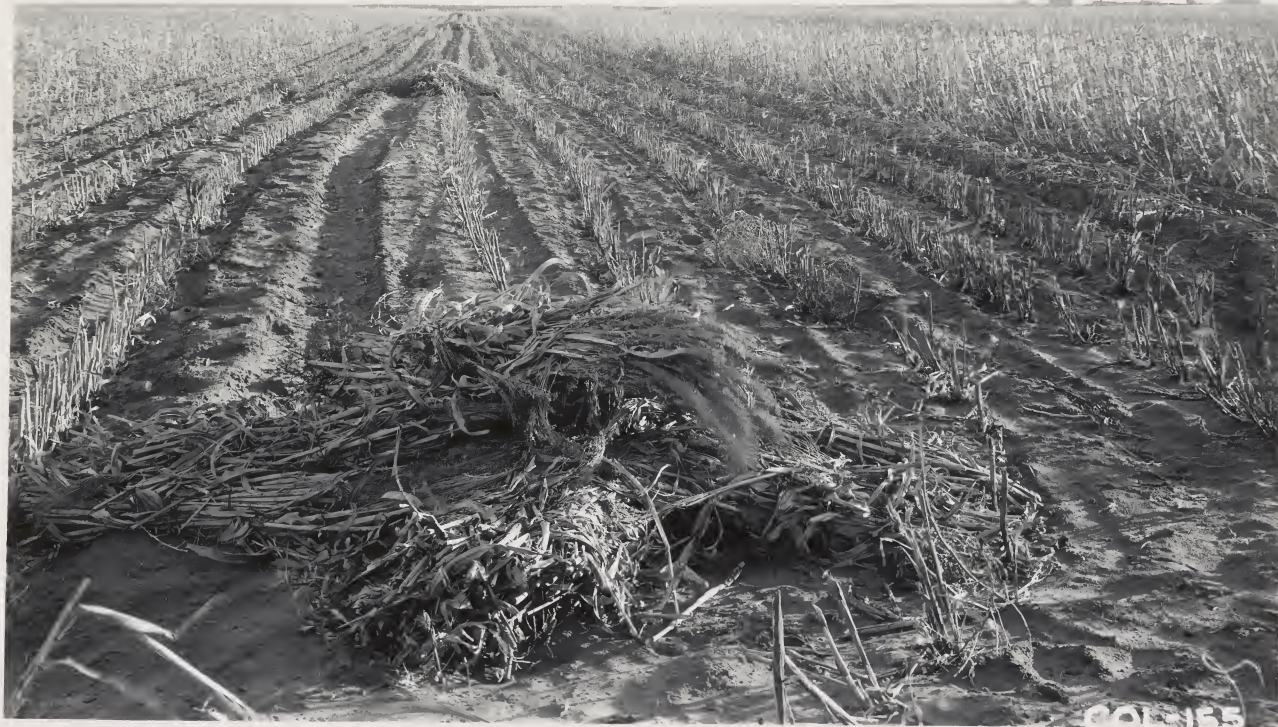
Colo-155

Showing method of harvesting crop and feed to prevent wind erosion. One strip is bound and the other strip is hand headed, leaving the entire stalk to hold soil from blowing. Cut stubble is about 10 inches high. Crop was produced on 6.92 inches of moisture.

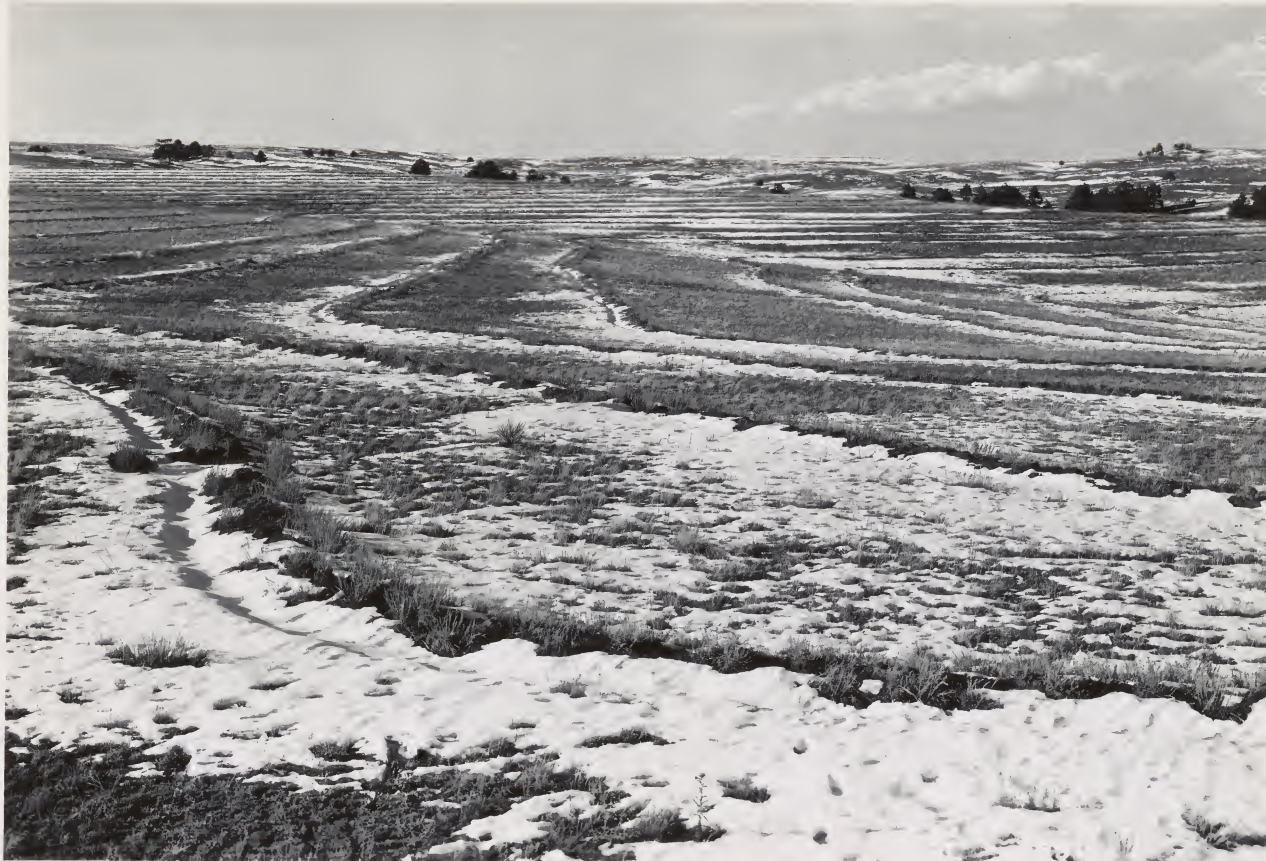
COL-3290

Colo-3290 El Paso County 10-10-38
Snow being in contour furrows along slope. Furrows constructed 1935.

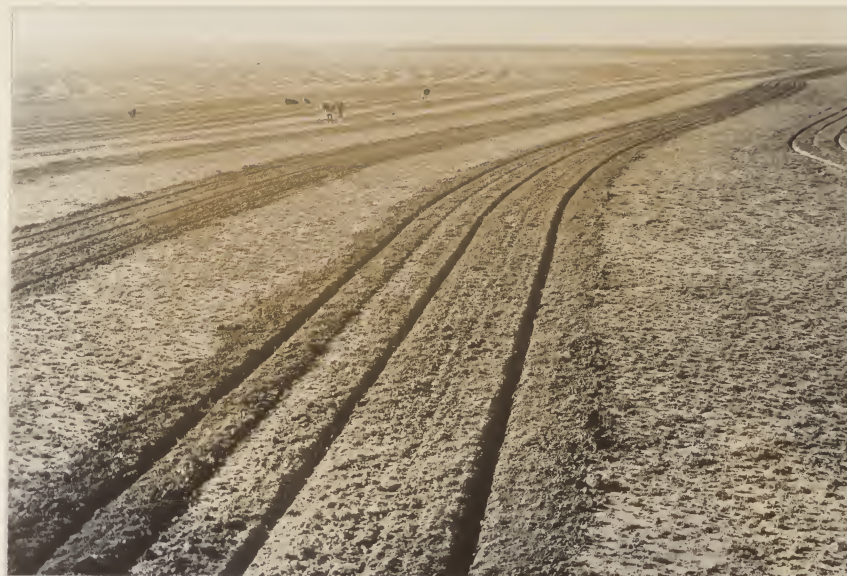
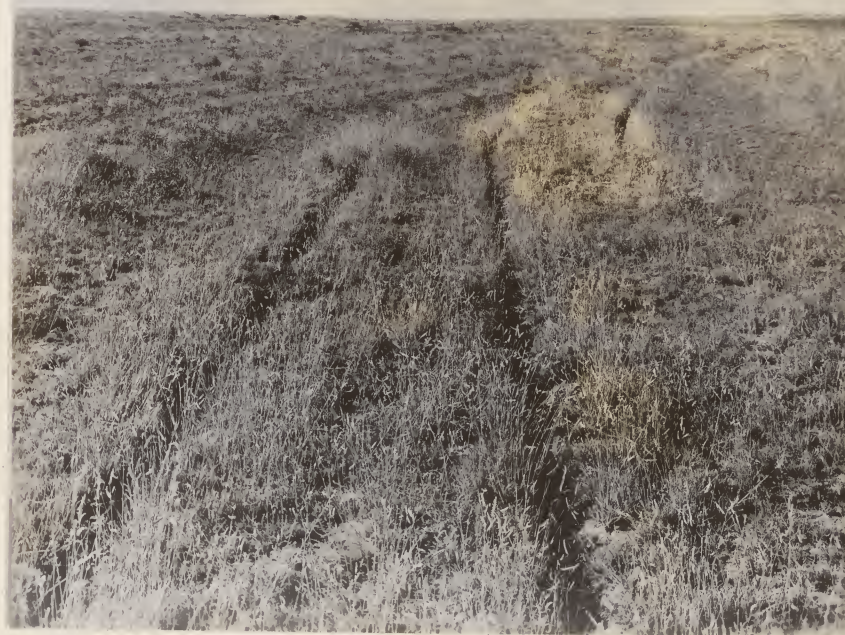
Colo-3637 Cheyenne County 10-6-37
Corrugation contour furrows on range land.

1. Constructed latter part of March and
early part of April, 1937.
2. Approximately 4 inches of rainfall on
furrows after completion.
3. Stand of grama and buffalo grass
improved 80 per cent.
4. 240 acres in this field of furrows
constructed in sets of three, cost
approximately 46¢ per acre.

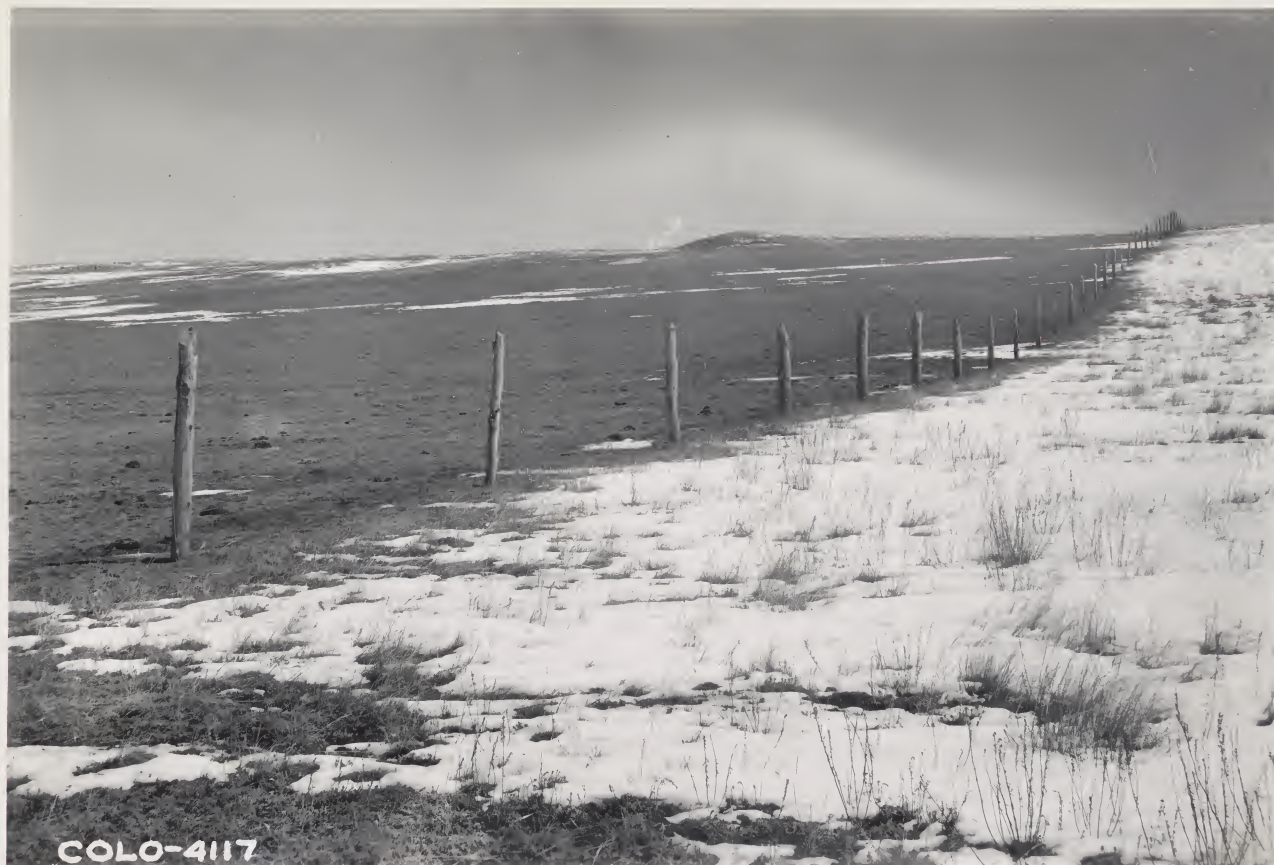
Colo-4117 Douglas County 4-9-38
Contrast in snow accumulation between overgrazed
area on left and ungrazed area in enclosure on right.
The only variable is in the density and height of
grass.

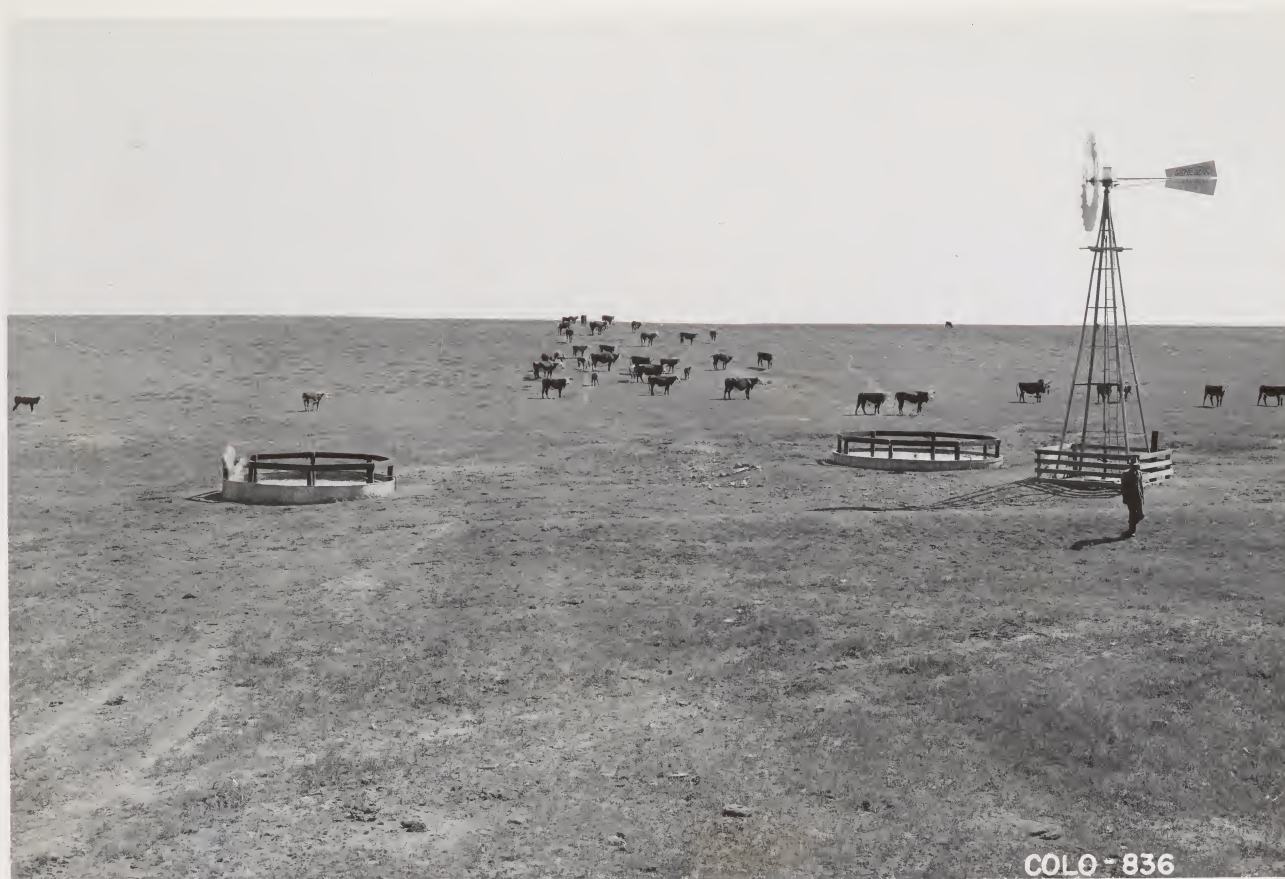
Colo-836

Typical stock water double tank and windmill constructed by SCS on Briggsdale LU Project. Stock do not have to travel over 2 miles for water on this range.

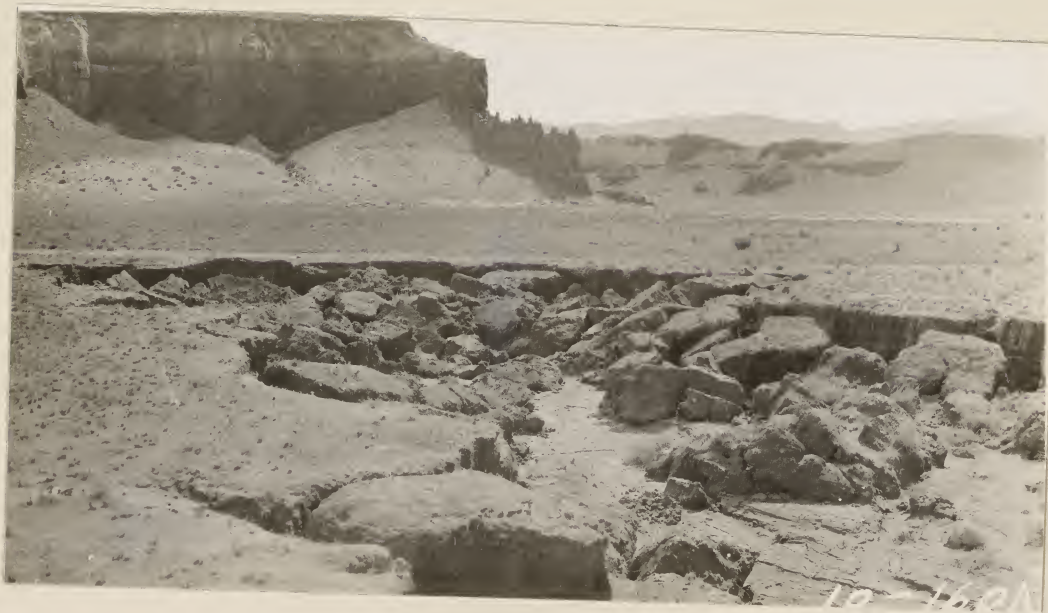
10-16QA - Albuquerque, New Mexico.
EROSION - Gully.

Gully cutting back into road between Chilchinbito and Kayenta.
May 1934.

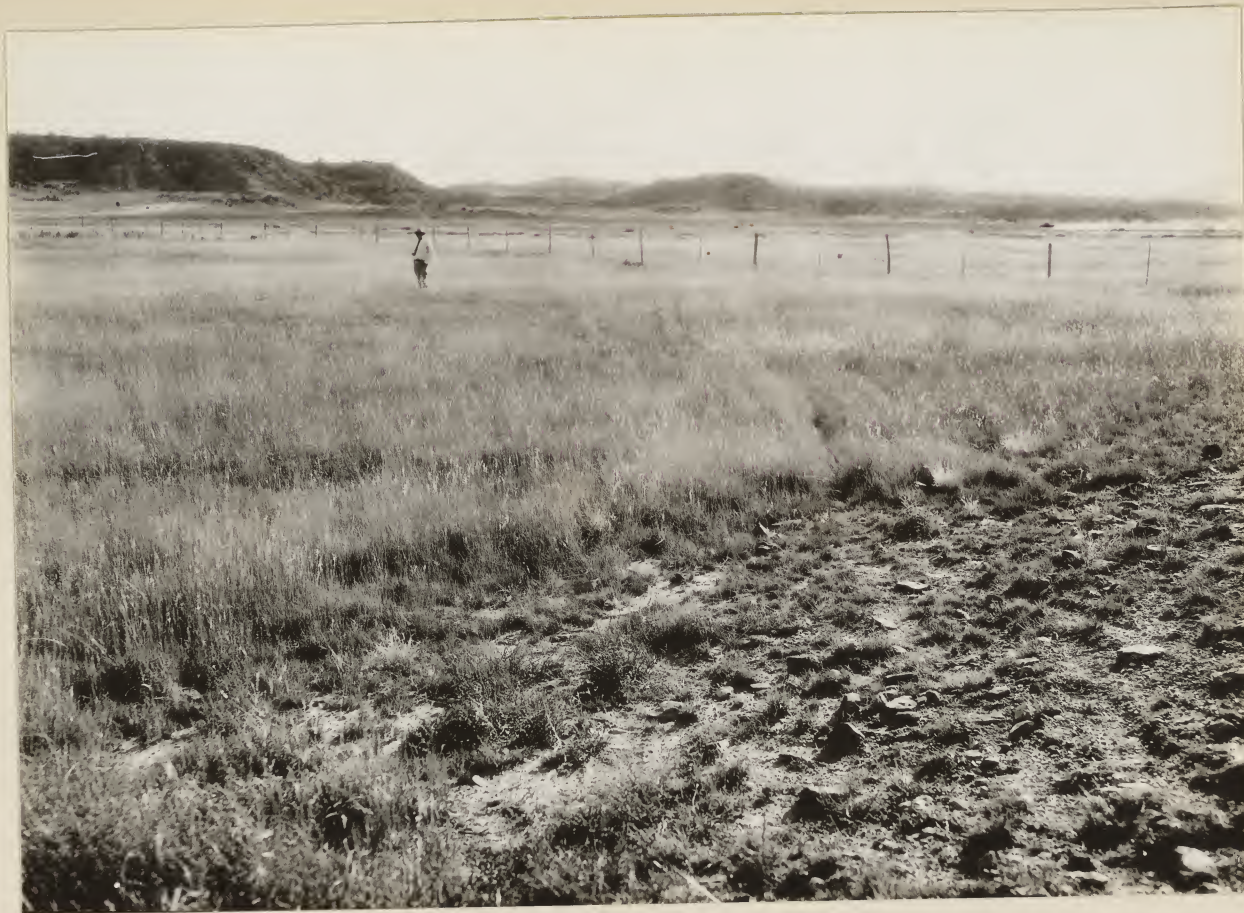
10 MS 1712 - Mexican Springs.
EROSION CONTROL - Dams.

View of vegetation developed by water diverted by Deer Springs Dam. First season. Mass of vegetation, chiefly Hilaria jamesii, clearly shows how far water reached. Leaves 10" tall. Flower stalks maximum 27". Higher water will develop adjoining areas in like manner. No seeding done here. Close-up of "water-line" about 3/4 miles below dam. Mexican Springs, October 1935.

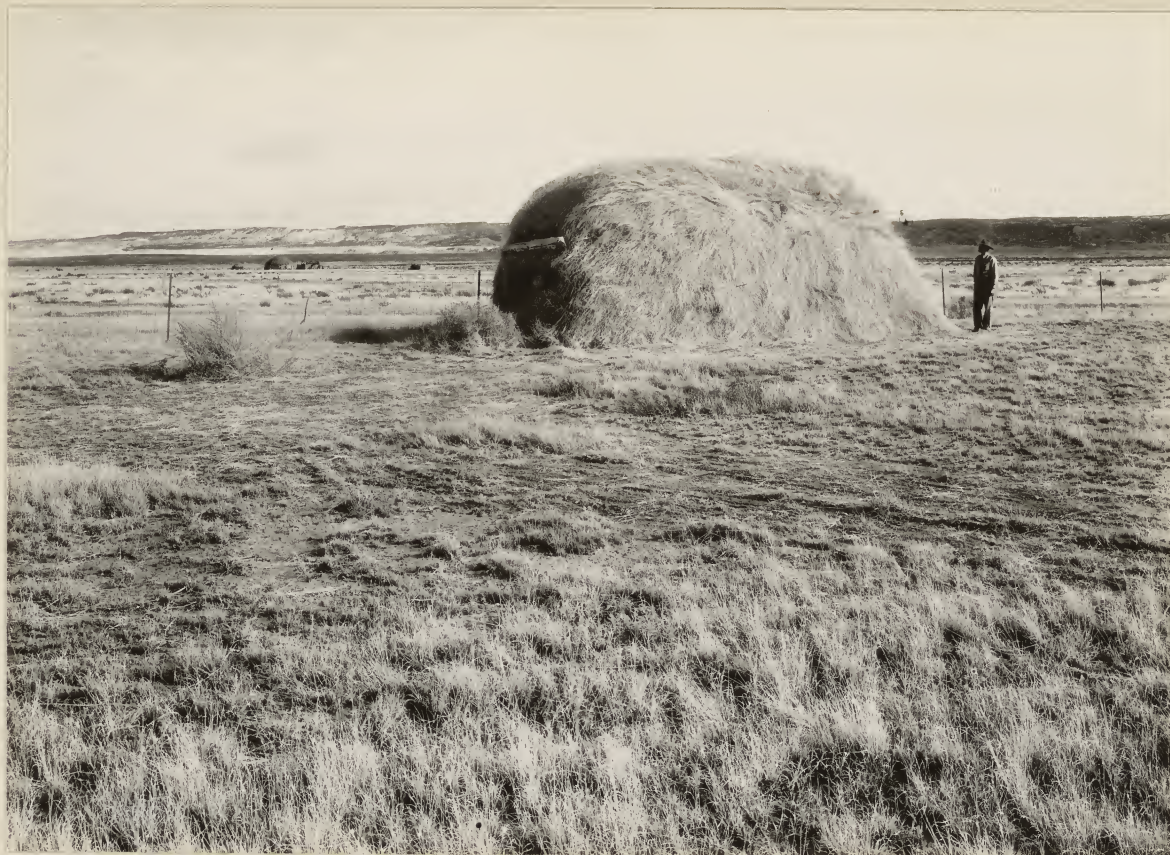
NM-594-A Union County 10-26-39
 Ada Gardner, Cooperator - Water Facilities, 31 miles southwest of Clayton,
 New Mexico. Water Facilities - SCS Gardner Dam. Water shoot (to step
 water down through 5 drops) 300 feet long, length $1\frac{1}{2}$ miles) to irrigate
 bottom land. Ditch was dug with blade. 1 per cent grade from dam. Photo
 Station No. 3.

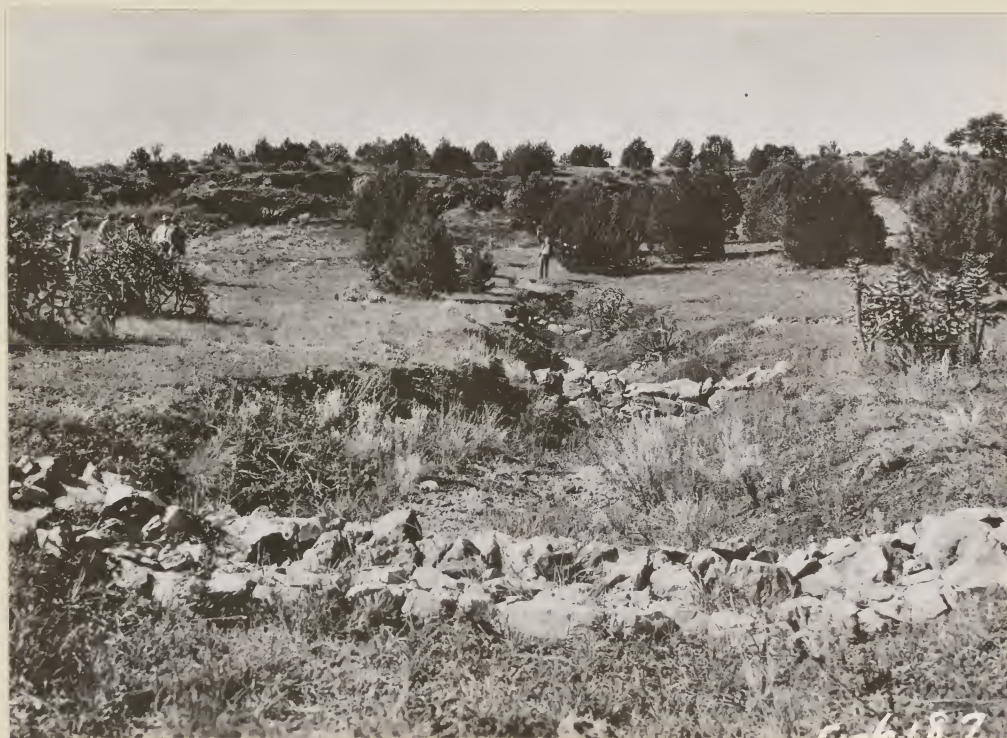
C-6187.

About 1 mi. w. of Silver City, N. M., head of gully
(upstream limit). June, 1937.
